LINCOLN DIVISION, Ford Motor Company

Service Bulletin

LINCOLN and the Continental MARK II

1955 - 1956 Technical Service Bulletins (TSB)

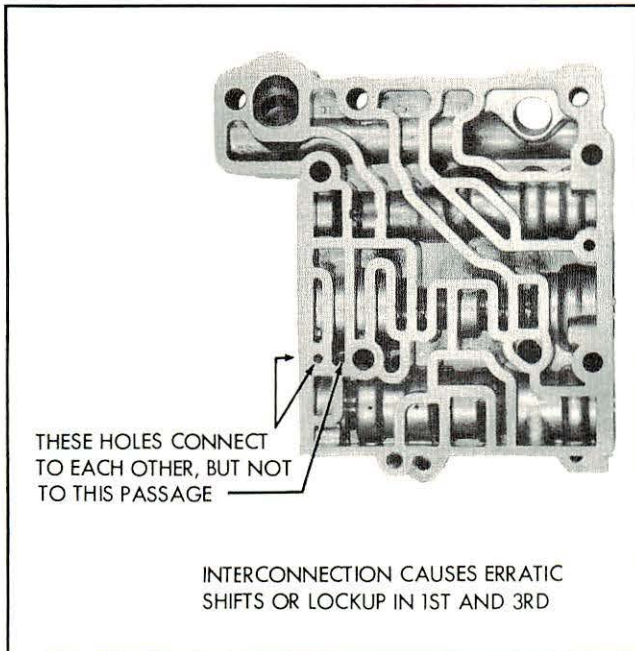
FIGURE 1 — LOWER VALVE BODY

In case of Band or Clutch failure in the subject transmissions, it is suggested that the control valve assembly be thoroughly cleaned and carefully inspected, giving particular attention to the points shown in the following illustrations.

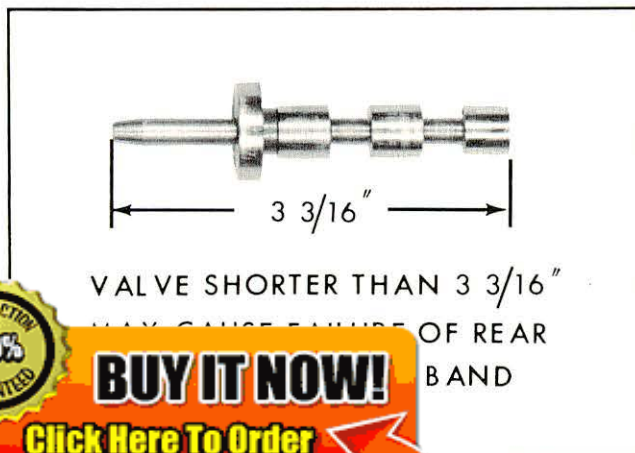
VALVE SHORTER THAN 3 3/16"
MAY CAUSE FAILURE OF REAR BAND

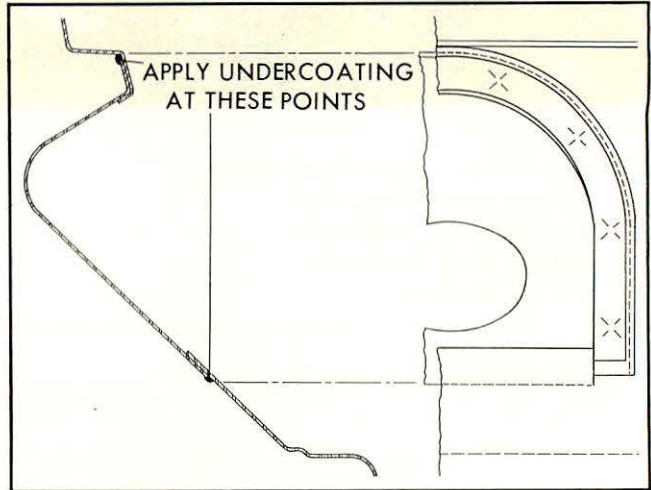
FIGURE 7 — SEALING LOWER BACK PANEL WELD SEAM

Gasoline fumes in the luggage compartment area may be coming through the weld seam where the lower back panel is joined to the gas tank filler pipe outer housing.

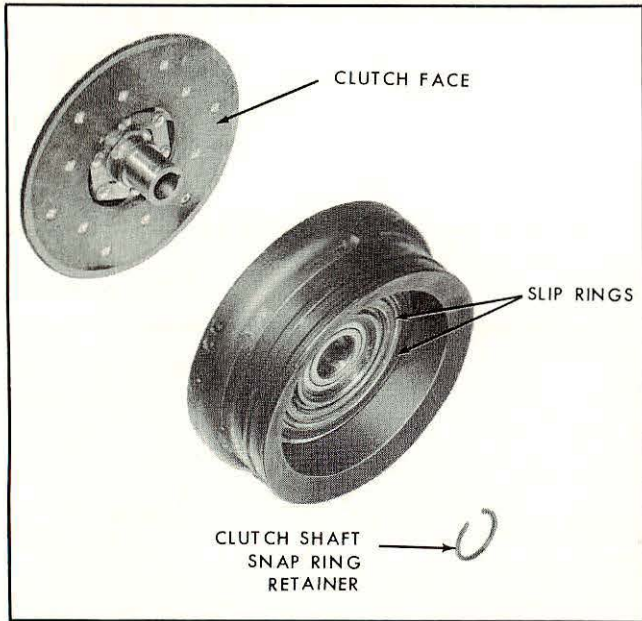
FIGURE 2 — ELECTRICALLY OPERATED CLUTCH

Proper operation of the clutch assembly may be easily checked because its operation can be seen and heard. When the clutch feed wire is energized, the front face of the clutch assembly snaps rearward and seats tightly against the sheaves.

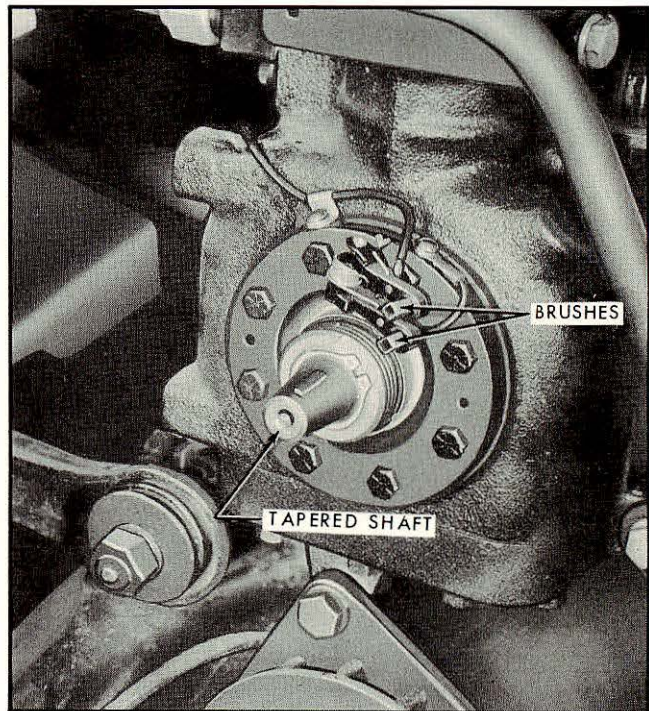
FIGURE 3 — COMPRESSOR ASSEMBLY, CLUTCH REMOVED

See figure 3. For this reason the 1956 Lincoln compressor is not interchangeable with the 1955 service compressor. The component parts of these compressors are alike, however, and existing service kits and procedures apply to each component except the drive pulley.

Following is the recommended sequence for installing the clutch assembly:

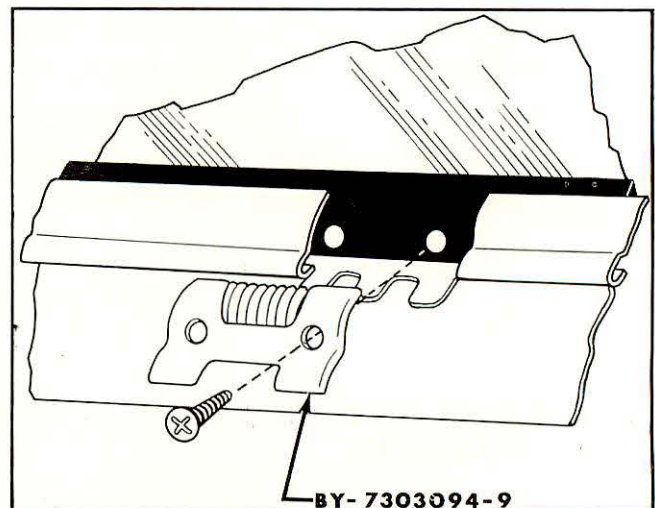
FIGURE 2 — WINDSHIELD BELT MOULDING JOINT COVER

On the 1956 Lincoln, when installing the Windshield Outside Belt Moulding Joint Cover, it is important that the attaching screws are not tightened too much. These screws should be torqued just enough to hold the cover securely. If they are turned in too far, there is a possibility that the additional strain will cause the windshield to crack. This cracking may not be noticeable until the vehicle has been exposed to changes in ambient temperature such as might be encountered

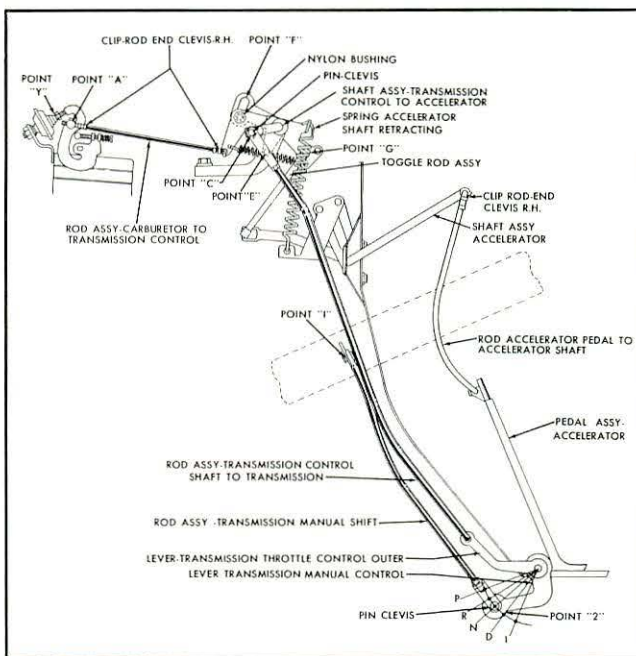
FIGURE 1 — THROTTLE LINKAGE

8. With the ignition off and accelerator pedal depressed to full kickdown position, adjust the length of the toggle rod assembly so that the nylon bushing nestles in the Transmission Control Lever slat at point "F" within .250" clear-

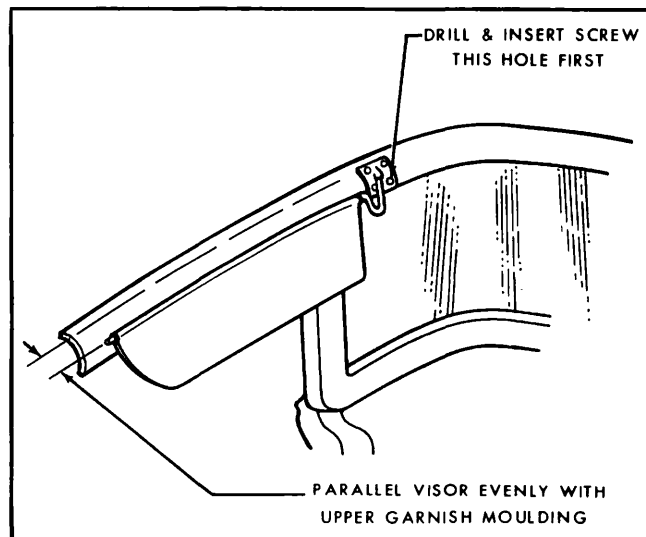
FIGURE 1 — RELOCATING SUN VISOR

Figure 1. With the visor in this position drill a hole in the visor mounting bracket. Insert a matching screw. In the next step, drill the remain-

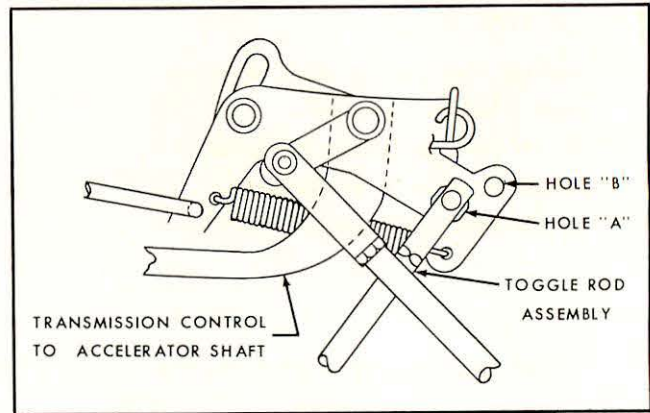
FIGURE 2 — CORRECT TOGGLE ROD INSTALLATION

It is extremely important that the toggle rod assembly be installed in the correct hole in the Transmission Control to Accelerator Shaft Assembly. Improper installation can result in poor shift characteristics. Hole "A" figure 2 should be used for Lincoln and hole "B" for Continental.

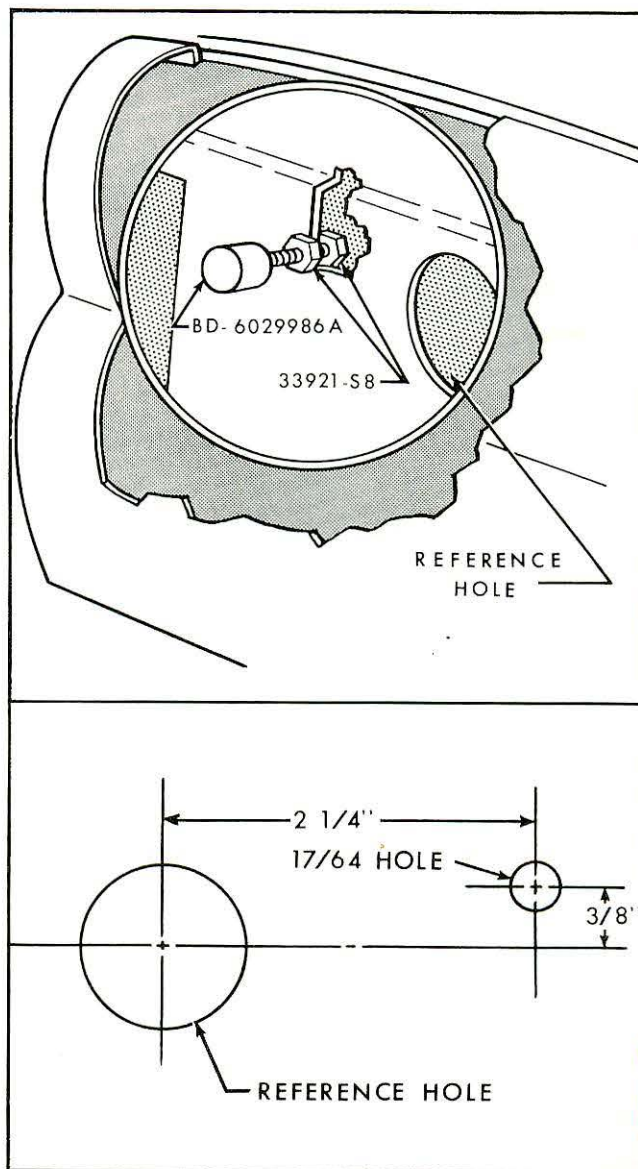
FIGURE 1 — INSTALLING REAR WINDOW BUMPER

Part number B5A-6029986-A is Ford controlled and is fully listed in the parts catalog. Inventory and stock is present in all General Parts Departments. All dealers' shops which stock

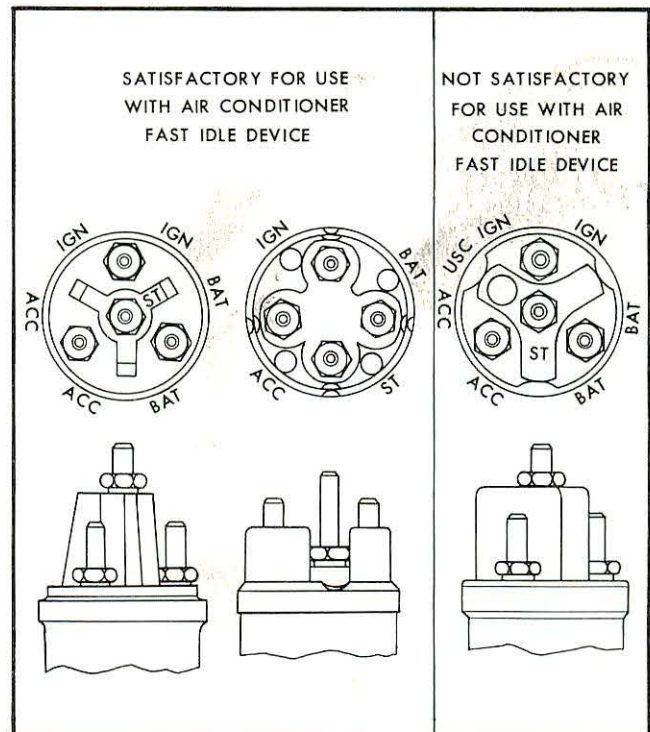
FIGURE 1 — 1956 IGNITION SWITCHES

When a fast idle device is installed in the field it is imperative that the ignition switch be inspected to determine its design. Figure 1 shows how to determine the satisfactory type switch. All switches are satisfactory for operation without the fast idle device installed.
